THE UNITED STATES
STRATEGIC BOMBING SURVEY

THE EFFECTS
OF
THE ATOMIC BOMB
ON
HIROSHIMA, JAPAN

Volume III

Physical Damage Division

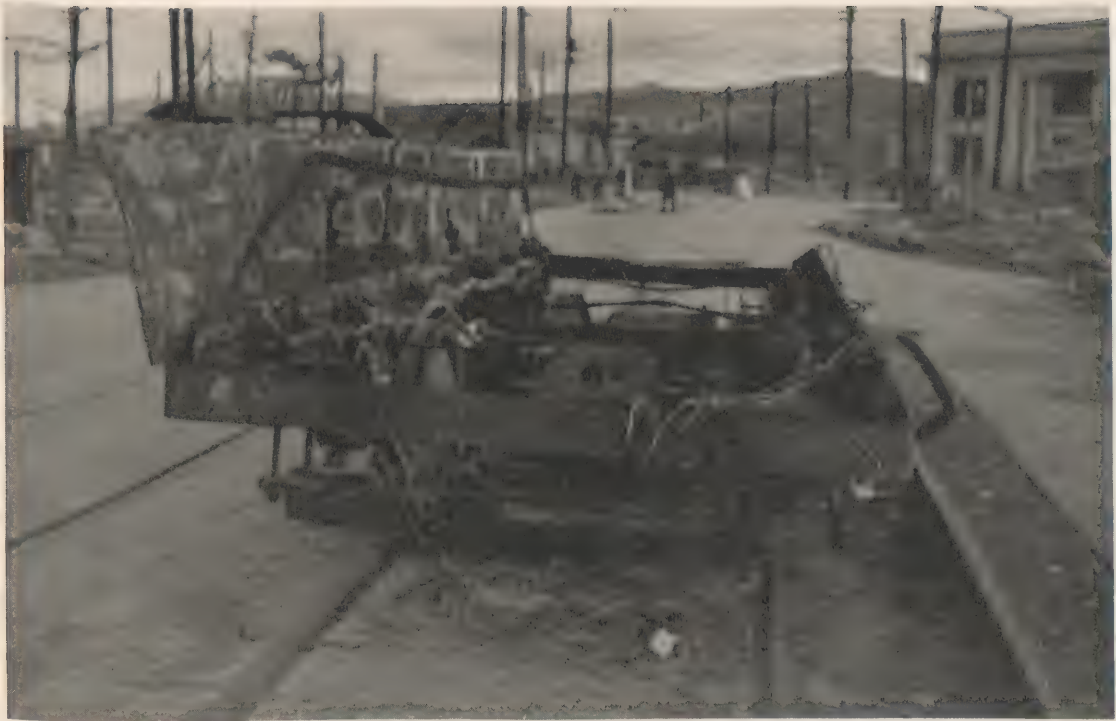
PHOTO 9-XIII. Damaged car 4,000 feet northwest of GZ.

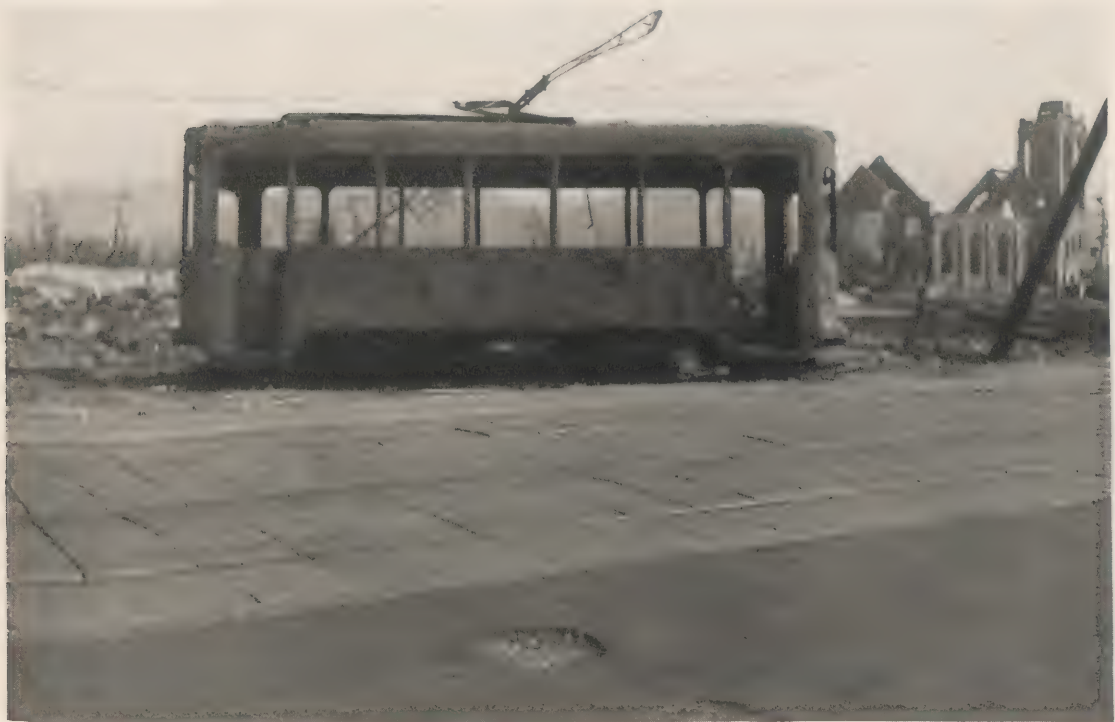
PHOTO 10-XIII. Damaged car 2,000 feet east of GZ.

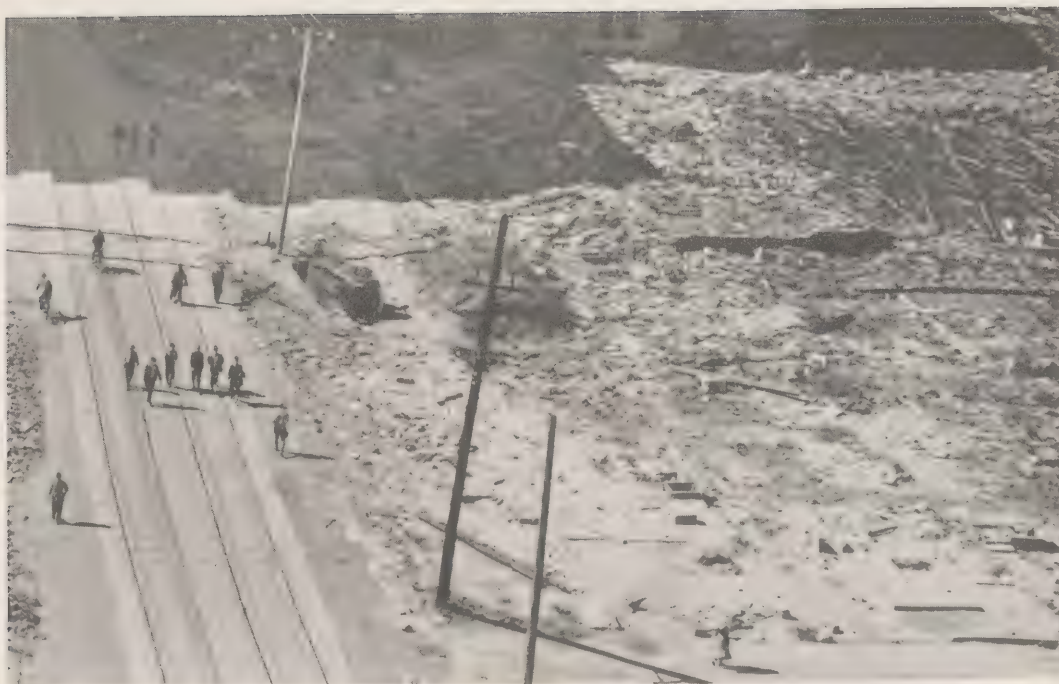
PHOTO 11-XIII. Damaged bus 2,500 feet east of GZ.

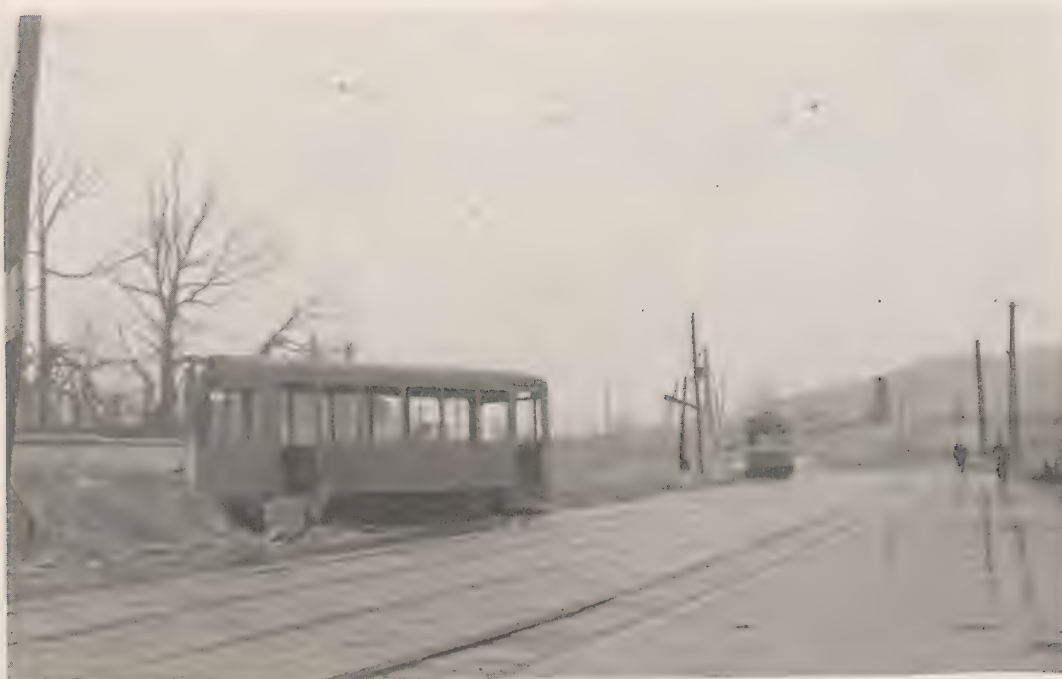
PHOTO 12-XIII. Damage to car 3,000 feet northeast of GZ.

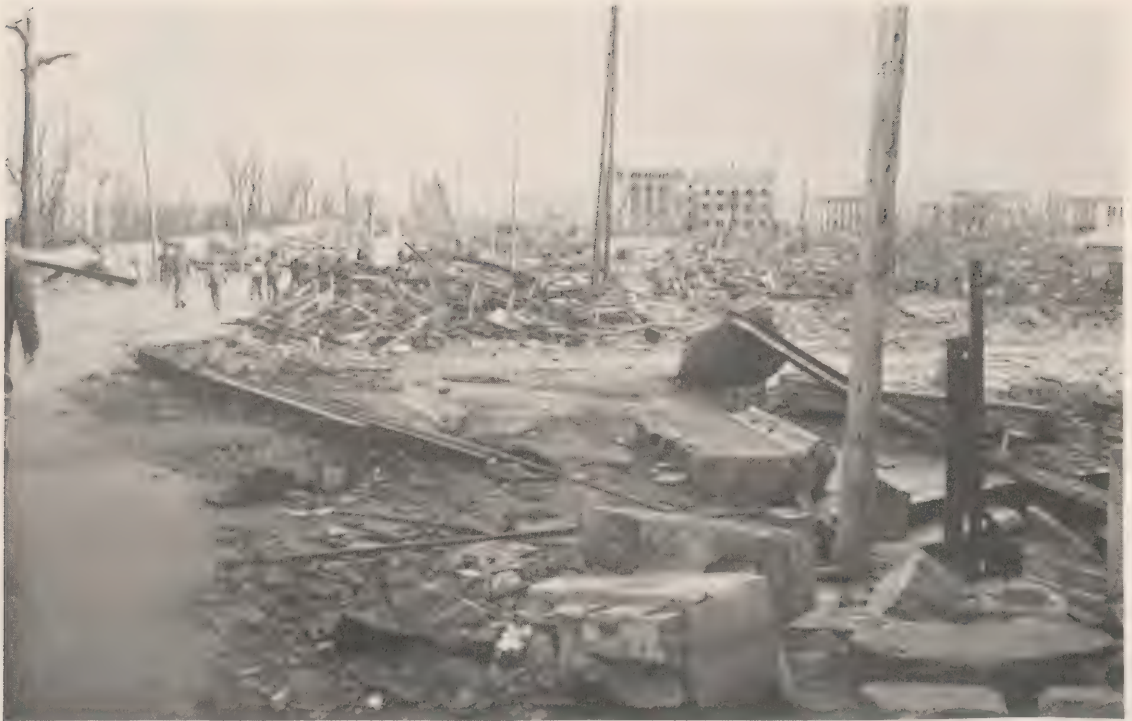
j. Of the 15.5 miles of railway system, 11.4 miles of overhead transmission were heavily or totally damaged (Fig. 1) directly as a result of the blast or by fires subsequent to the blast. Results of a survey by the company, accounting for 500 wood poles and 100 steel poles damaged by fire and blast (Photos 15 through 21) owned by them are shown in Table 4, giving the maximum limit of damage.

PHOTO 15-XIII. Blast damage to steel poles, 600 feet from GZ, and wood pole replacements.

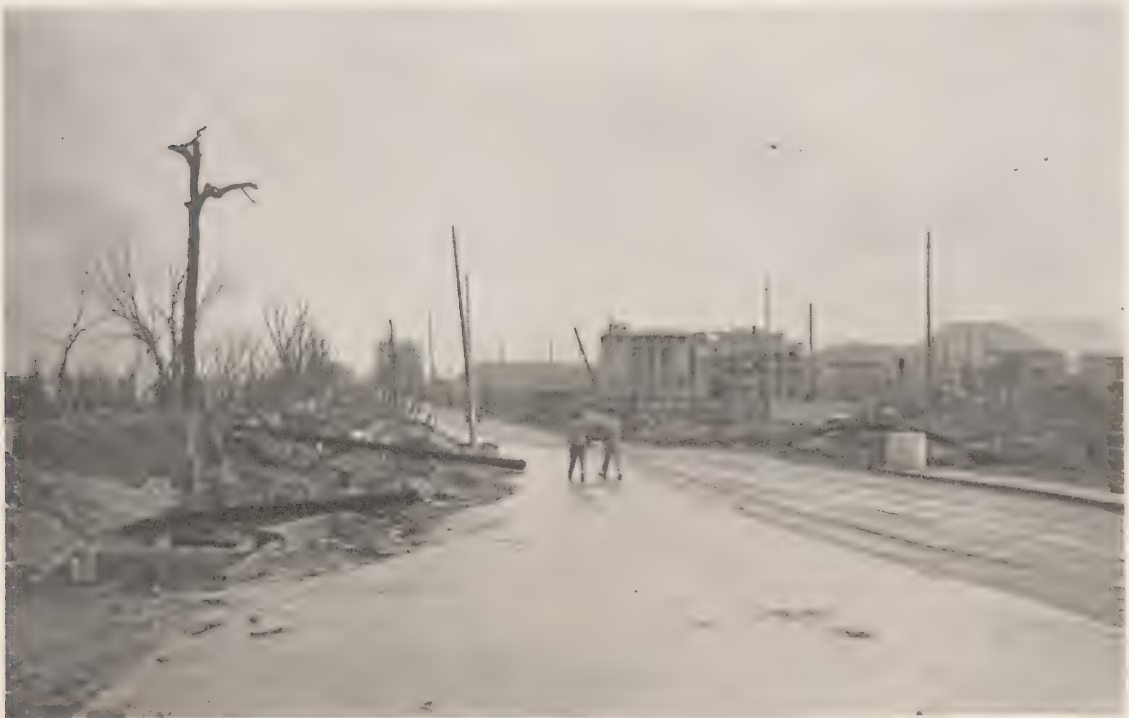
PHOTO 16-XIII. Wood poles broken off at ground by blast 600 feet from GZ.

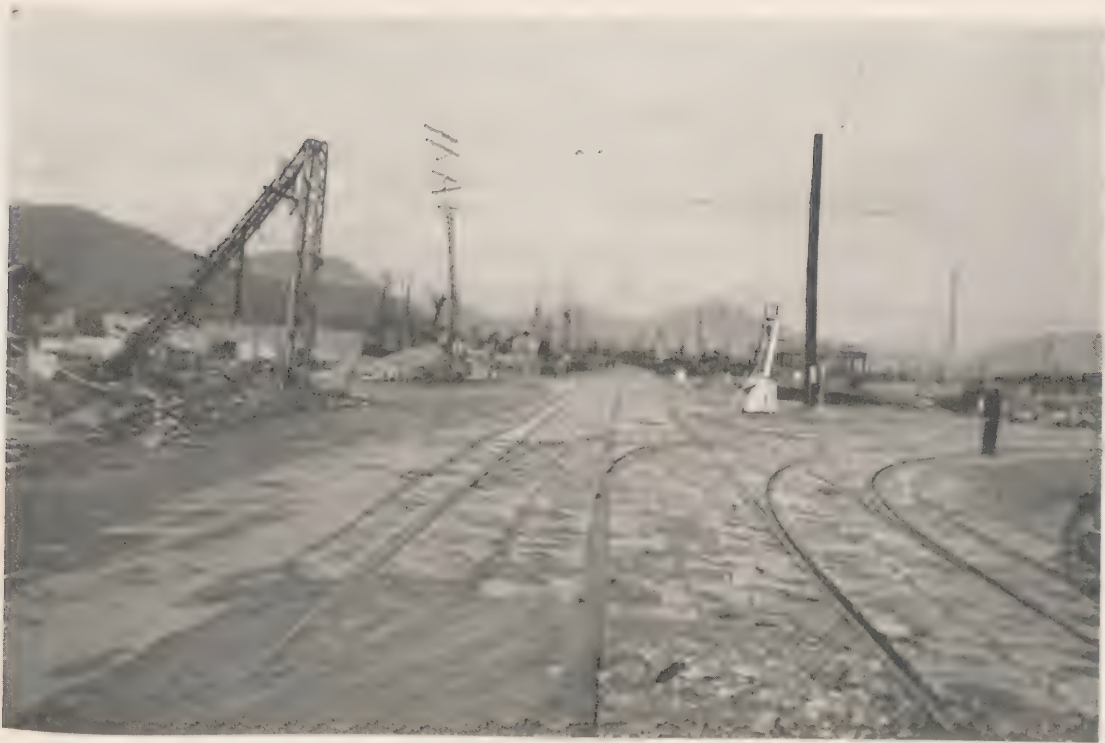
PHOTO 17-XIII. Blast damage to poles 2,000 feet west of GZ.

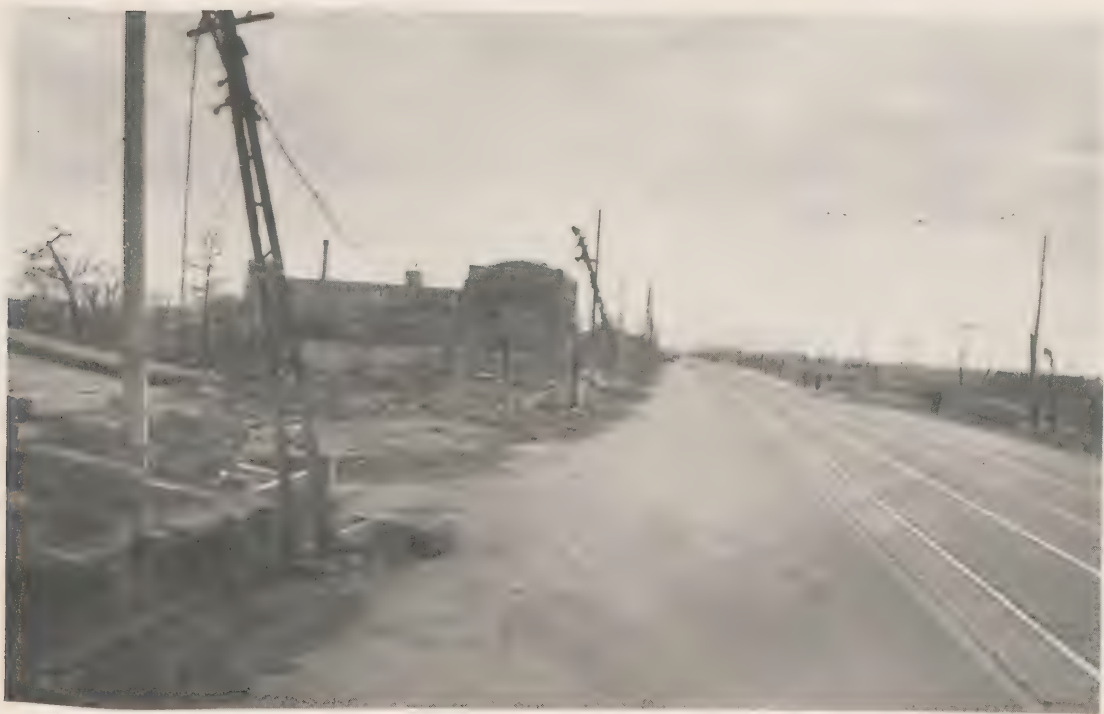
PHOTO 18-XIII. Bent steel and fractured wood poles 3,000 feet southeast of GZ.

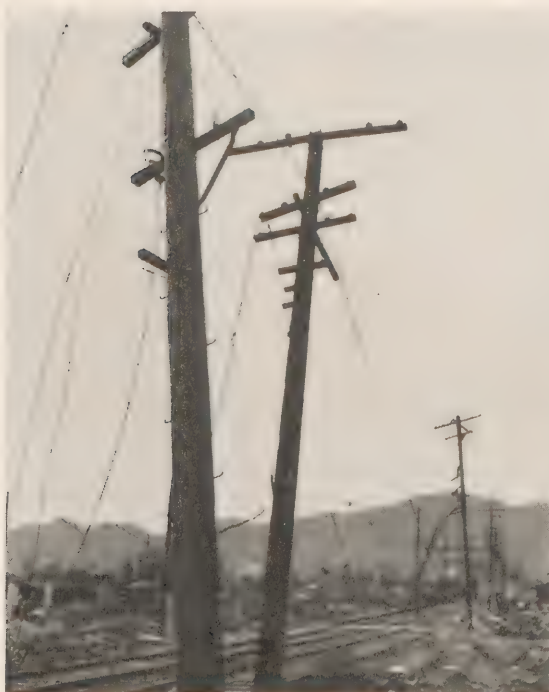
PHOTO 20-XIII. Damaged cross arms 3,000 feet west of GZ.

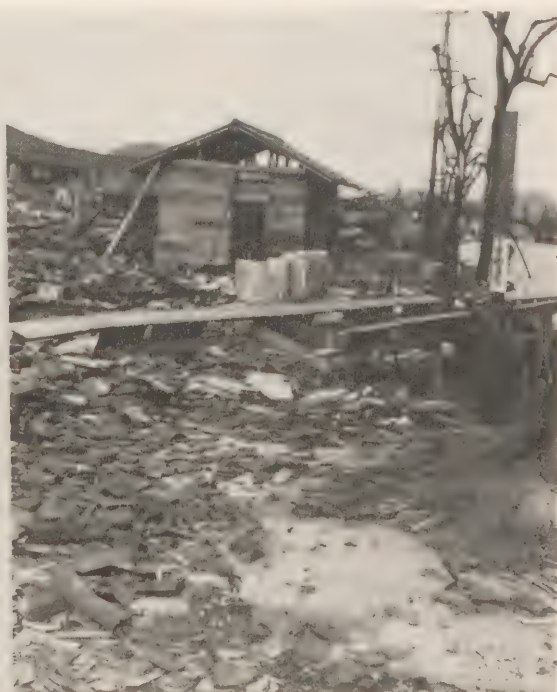
PHOTO 21-XIII. Blast damage to steel pole 3,500 feet from GZ.

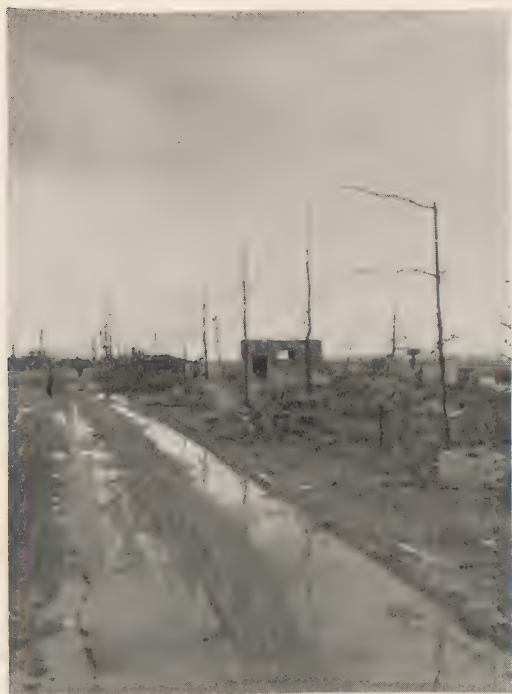
Type 3 poles were owned and maintained by the Chugoku Electric Co., but the Hiroshima Railway Co. was allowed the privilege of overhead attachment because of the joint agreement previously mentioned. The steel-lattice poles were bent at the base by the force of the blast at 6,000 feet from GZ (Photo 22). The concrete poles at 6,000 feet (Photo 23) from GZ were undamaged. Although poles were intact and standing, the overhead cable was blown down by blast 8,000 feet from GZ (Photo 24). Some new poles necessary to operate the portions of the system in use were installed, and the partly damaged poles were utilized. The whole system was of a temporary nature and replacement of the majority of the overhead lines would have been essential for continued operations.

PHOTO 22-XIII. Damage to steel poles
6,000 feet southeast of GZ.

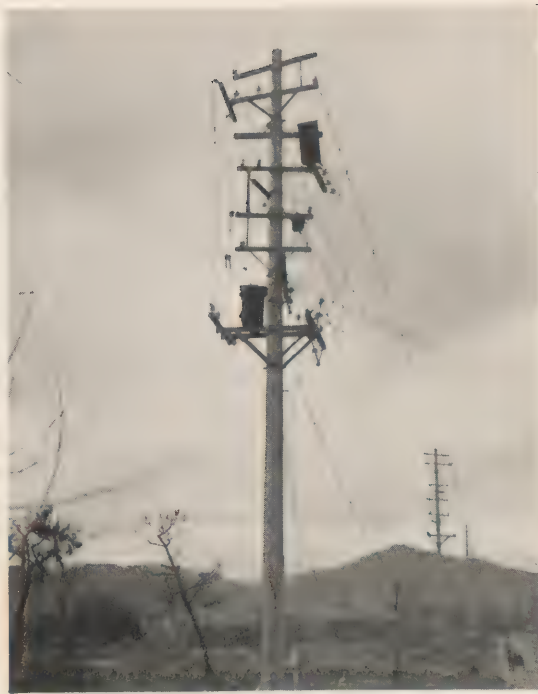
PHOTO 23-XIII. Standing concrete poles 6,000
feet east of GZ.

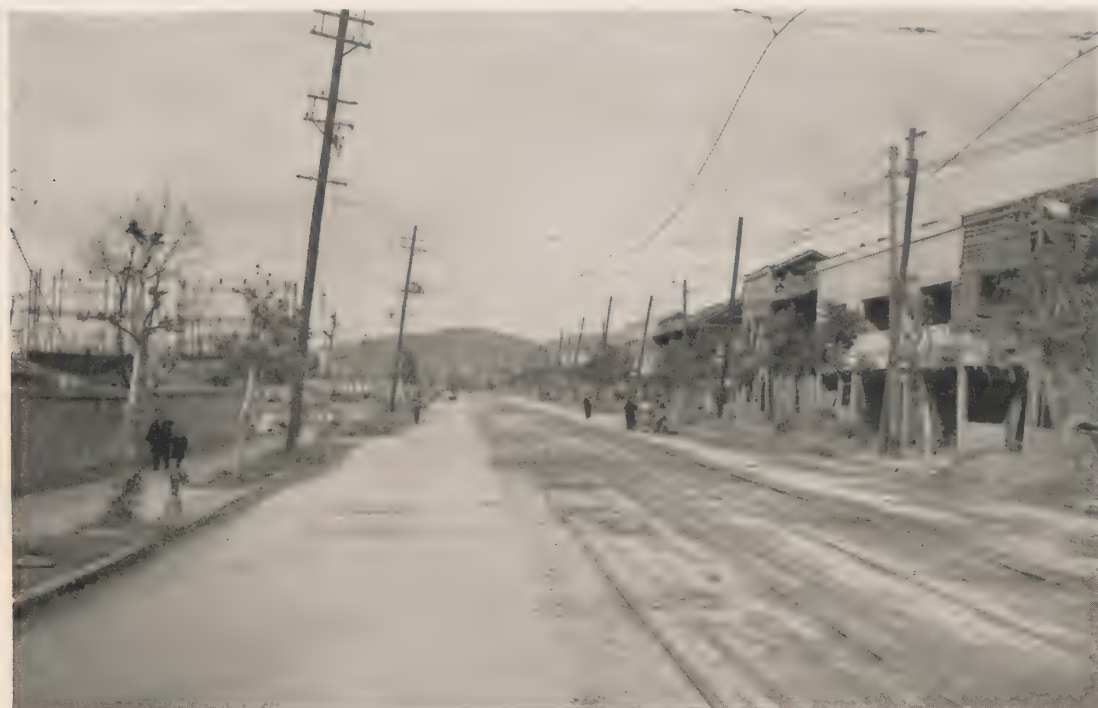
PHOTO 24-XIII. Damaged overhead 8,000 feet southeast of GZ.

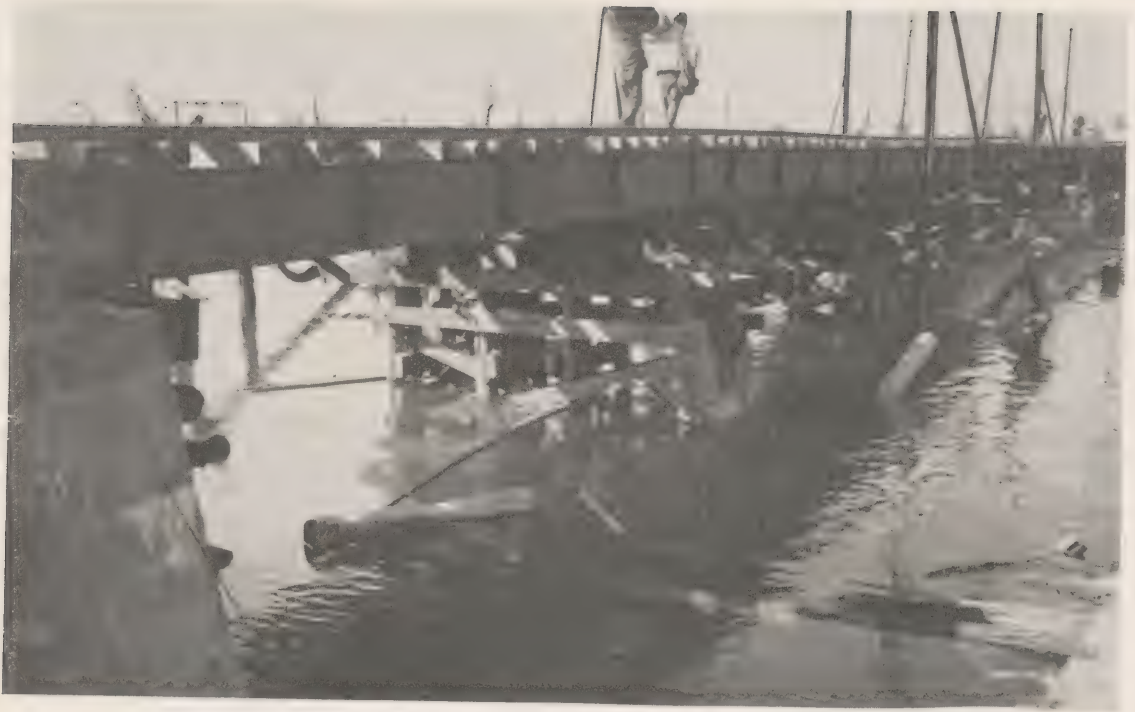
k. No actual damage to the track system, except at bridges, could be determined either by the railway company or by the members of the team. Bridge 13 (Photos 25 and 26) was depressed approximately 20 inches, preventing traffic over the Kyobashi River. Bridge 24 was subjected to a

PHOTO 25-XIII. Streetcar Bridge (13) damaged by blast and flood, 4,700 feet from GZ.

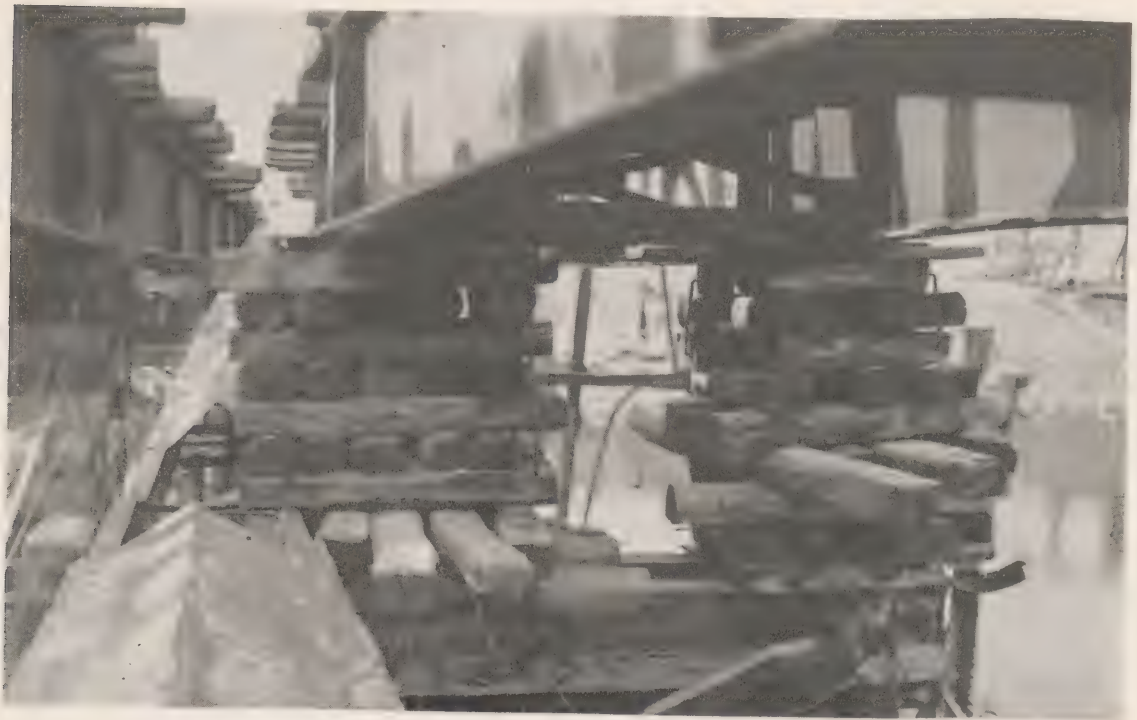
PHOTO 26-XIII. Temporary repairs to stabilize car tracks on Bridge 13.

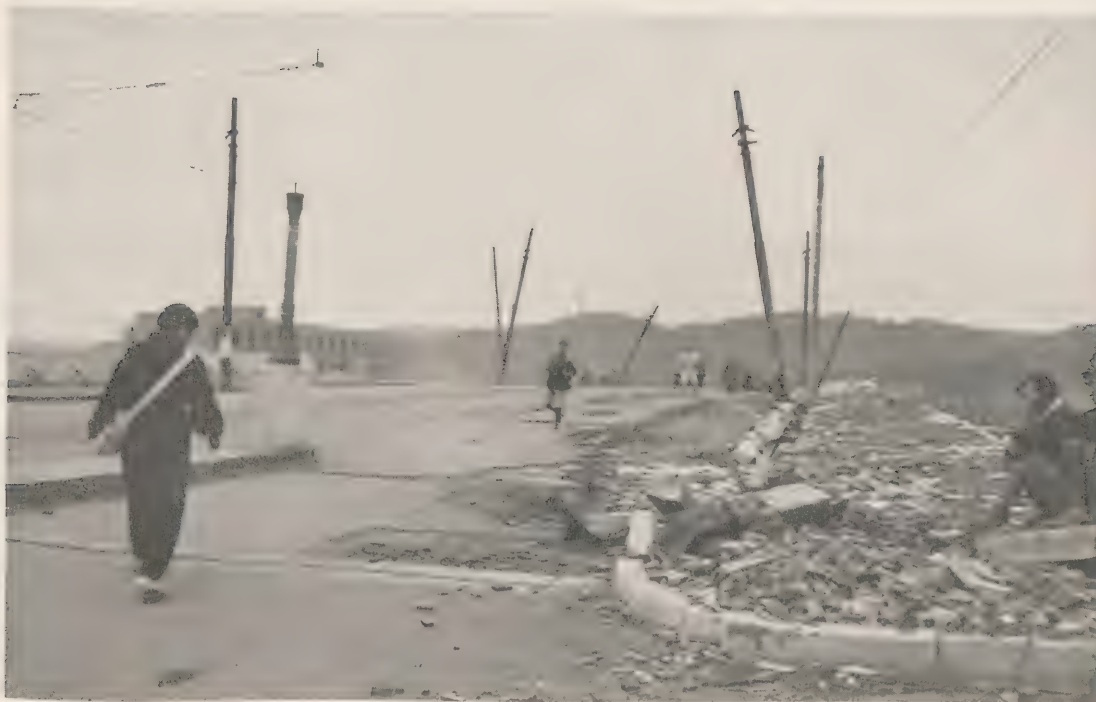
PHOTO 27-XIII. East approach to Bridge 24 showing blast damage, 1,000 feet from GZ.

severe depressive and rebound action that displaced tracks (Photos 27 and 28) on the bridge. In addition to damage attributed to the attack, the severe floods of 17 September 1945 and 5 October 1945 damaged Bridges 28 and 35 (Photo 30). Bridge 13 was also further damaged by floods. The following (Table 5) is taken from Section XII, Damage to Bridges, bound herewith, and indicates the damage to bridges in each instance:

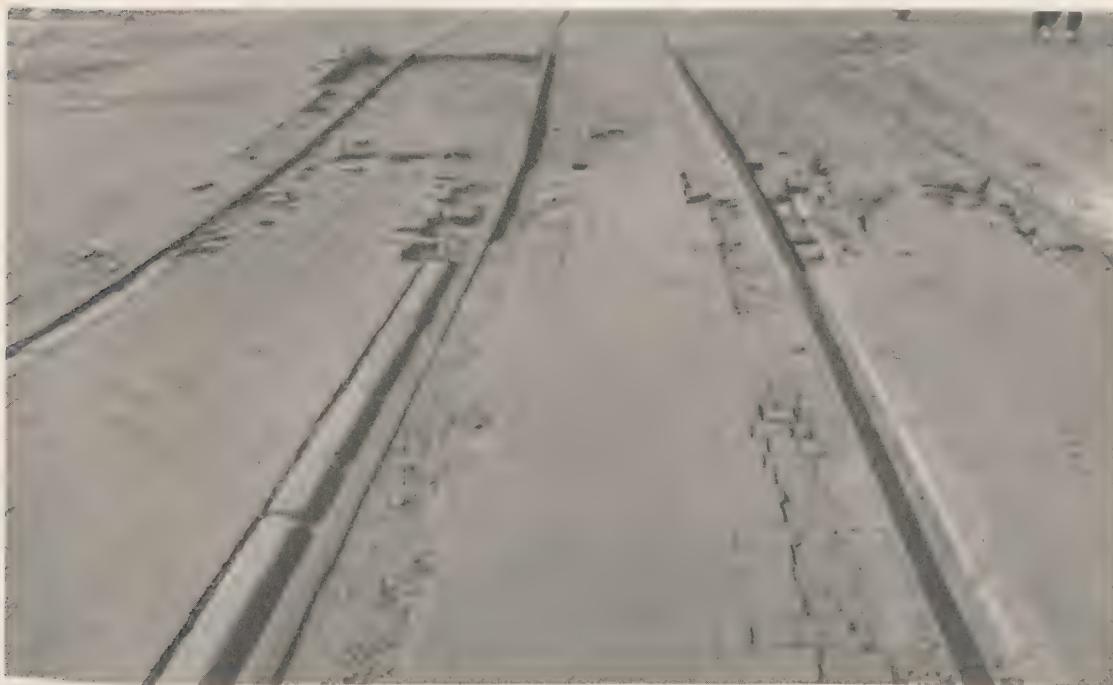
PHOTO 28-XIII. West approach to Bridge 24 showing displaced tracks.

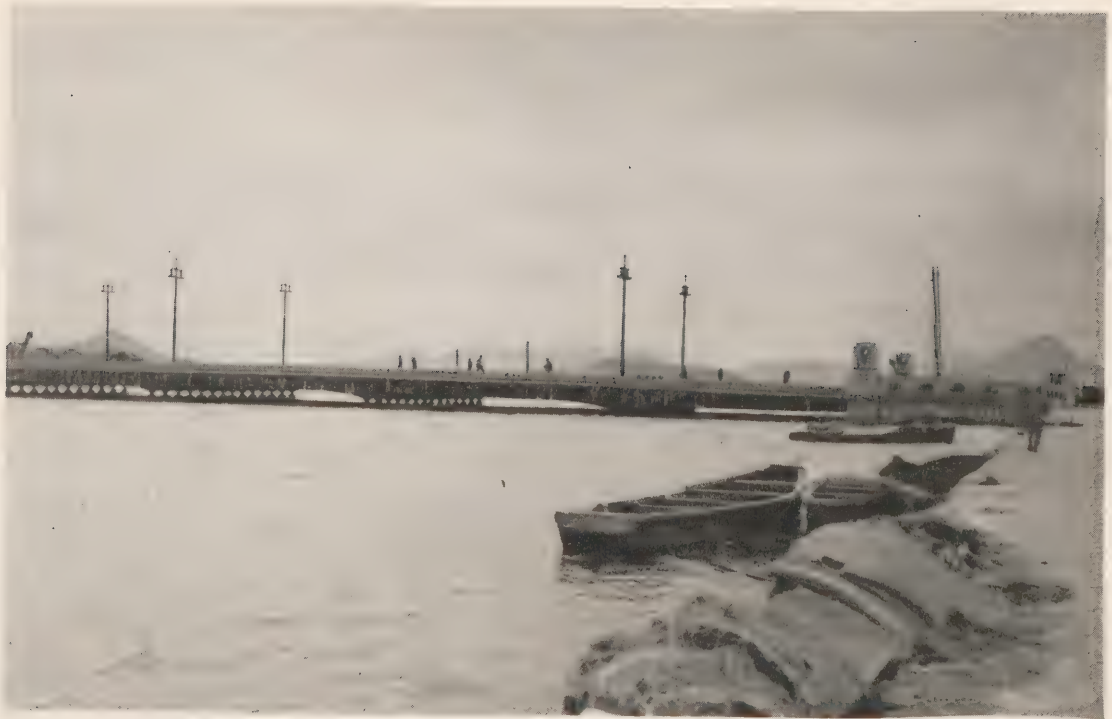
PHOTO 29-XIII. Bridge 17 showing high water on 23 October 1945.

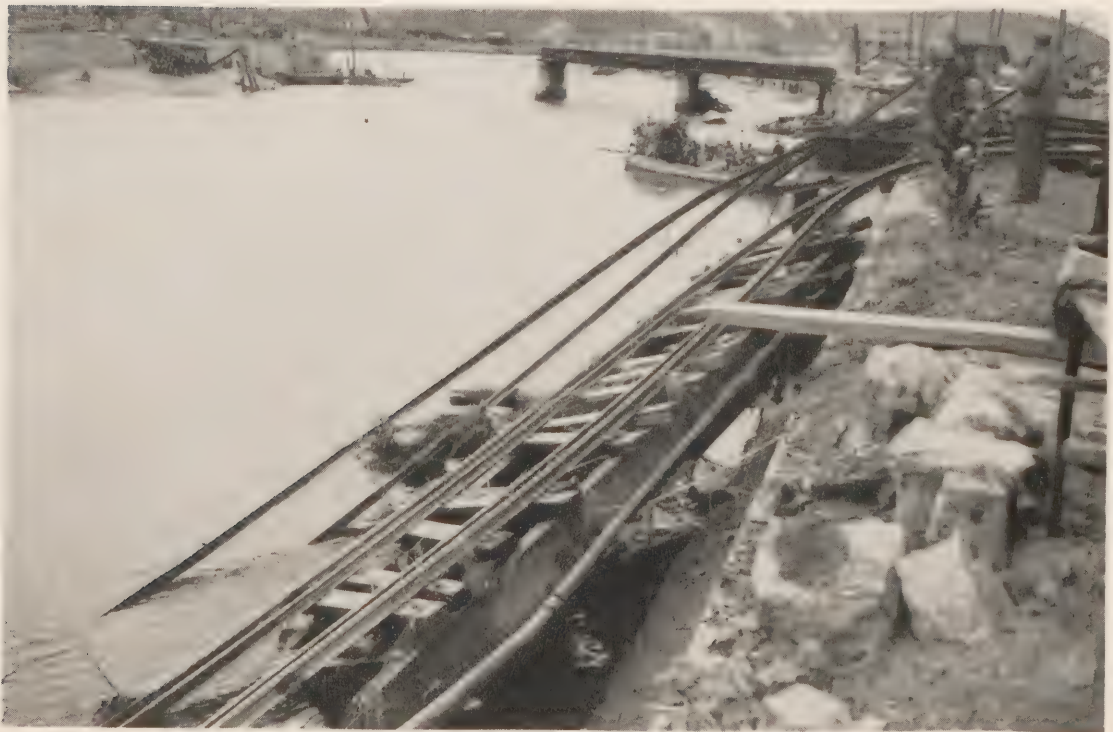
PHOTO 30-XIII. Flood damage at Bridge 35. Ferry transportation across the Temma-Gawa.

Bridge 35 during the flood period hampered transportation only insofar that passengers had to cross the river by ferry (Photo 30) or by other bridges on foot, and take the shuttle between Koi and the Temma River.

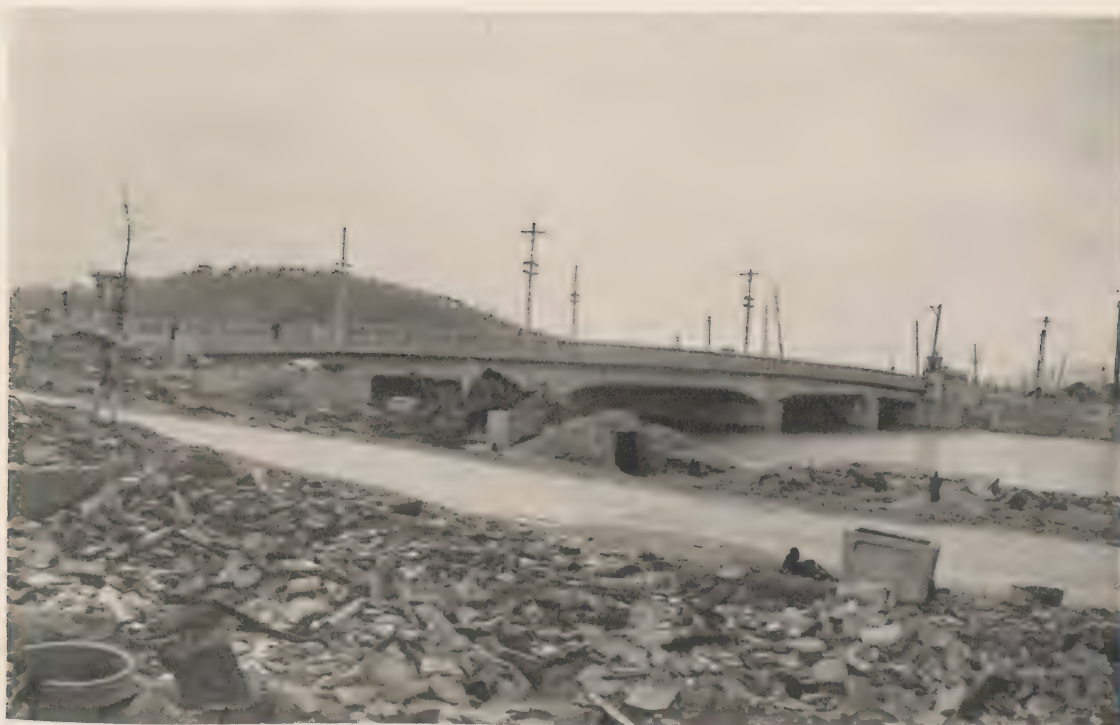
PHOTO 31-XIII. Undamaged, street car over-crossing at Bridge 4, 6,500 feet from GZ.

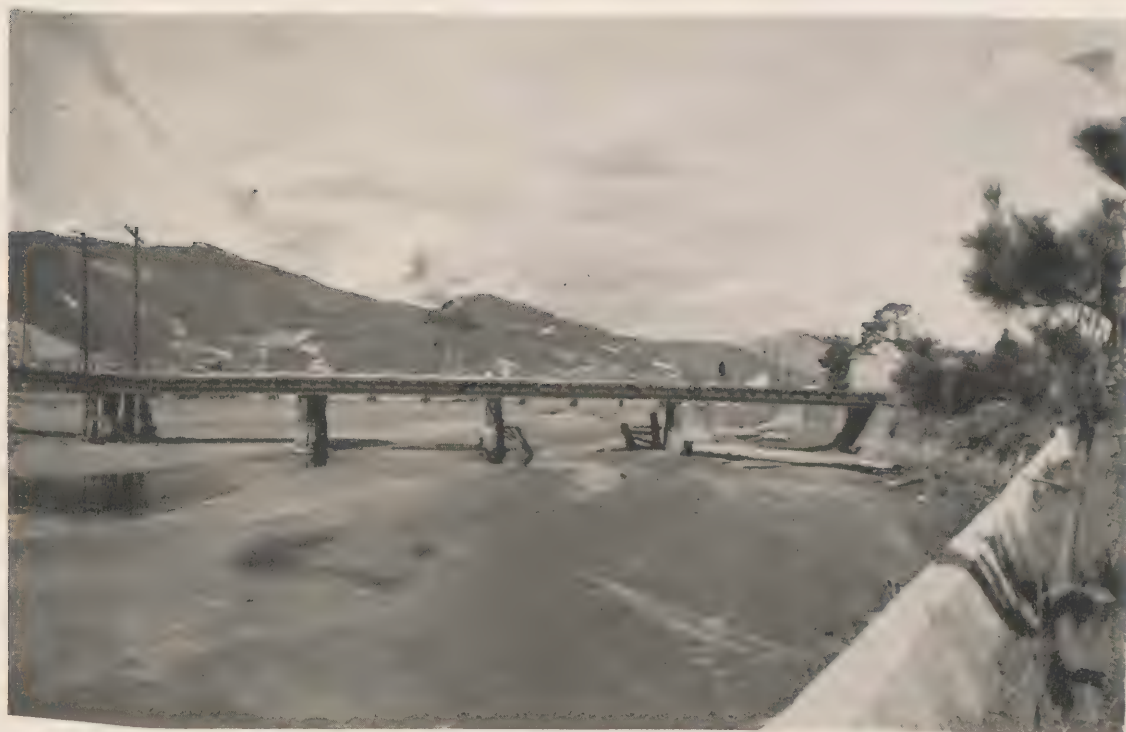
PHOTO 32-XIII. Undamaged, street car over-crossing at Bridge 44, 5,300 feet from GZ.

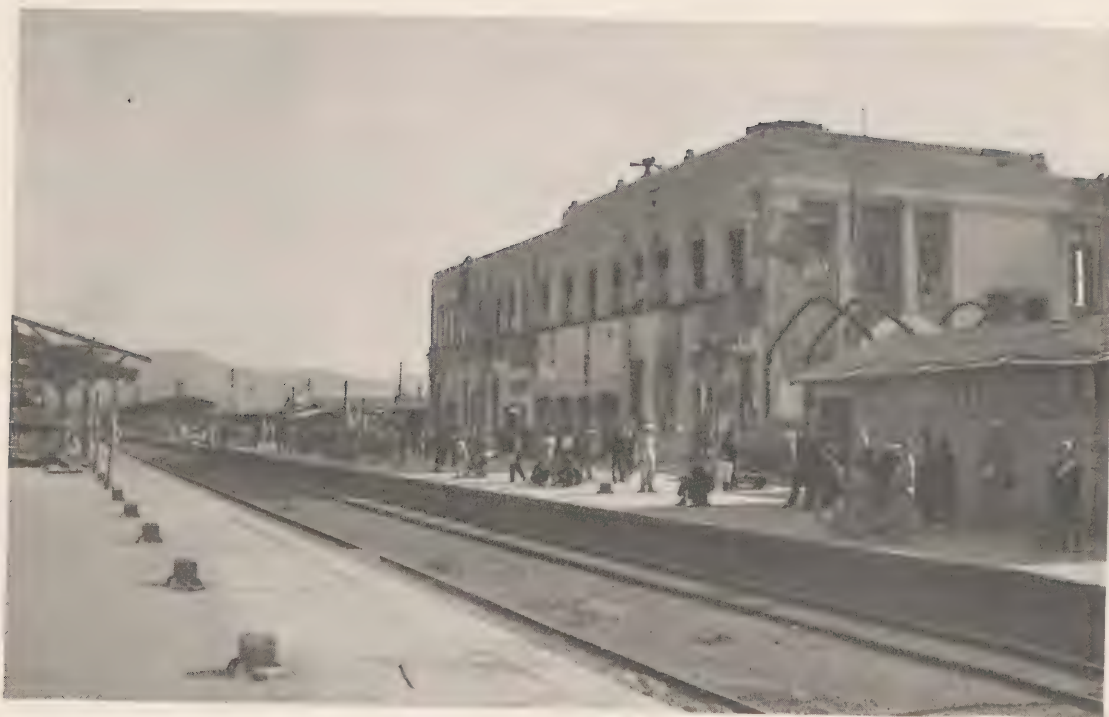
PHOTO 33-XIII. Passenger station and shelter damaged by fire and blast, 6,300 feet from GZ.

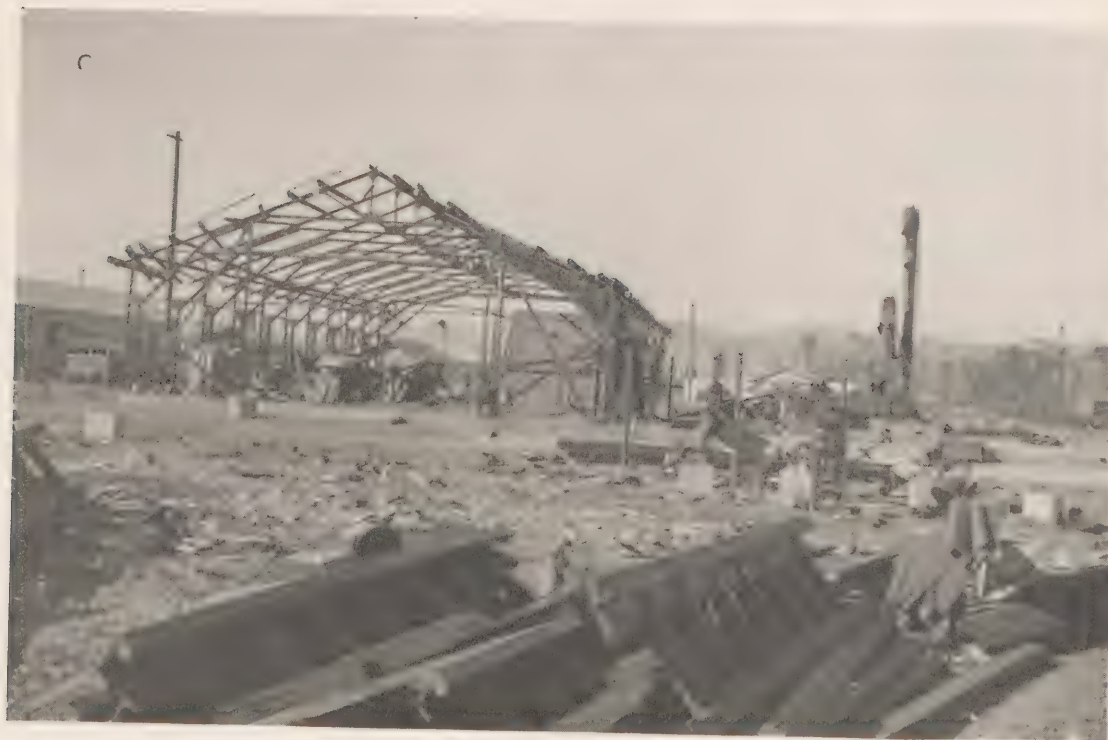
PHOTO 34-XIII. Railroad printing building damaged by fire, 5,800 feet from GZ.

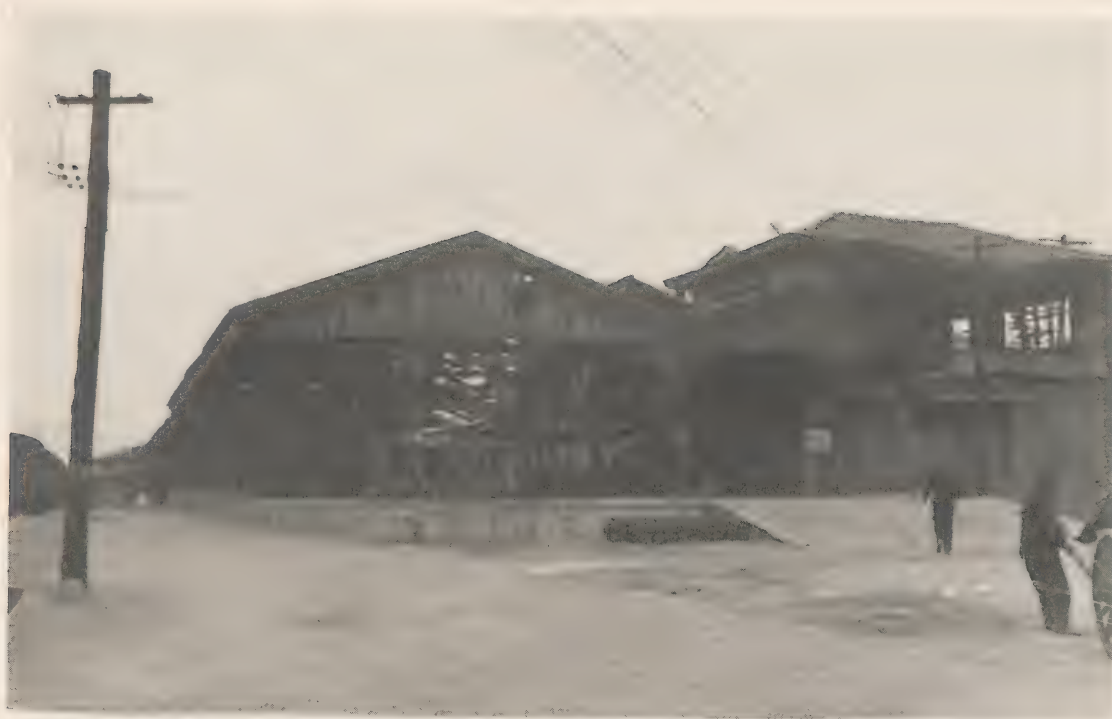
the warehouses, repair shops, and engine sheds (Fig. 7) which were classified as wood-frame, commercial-industrial structures were damaged by blast (Photos 36 through 44). Roundhouse 1 received only minor damage (Photo 45). This area was between 8,000 and 10,000 feet from GZ. Because of the disruption of power facilities at the Dambara substation from which the railroad electrical equipment was supplied, no electrical power was available. Bunkers, cranes, and pedestrian overcrossings were undamaged (Photos 46 and 47), but lack of electrical power prevented the coaling operations of the cranes. When electrical power was restored on 9 August 1945, coaling service was resumed, and repairs in the roundhouse were continued.

PHOTO 38-XIII. Superficial blast damage to transit sheds, 8,500 feet from GZ.

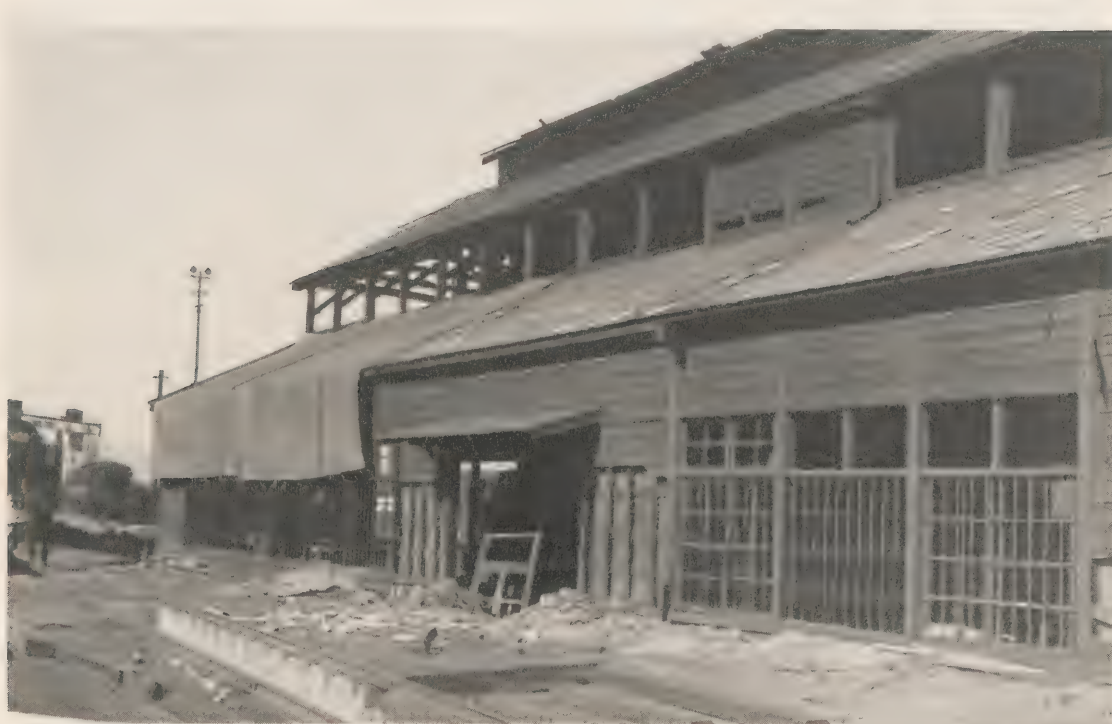
PHOTO 39-XIII. Engine inspection building damaged by blast, 9,800 feet from GZ.

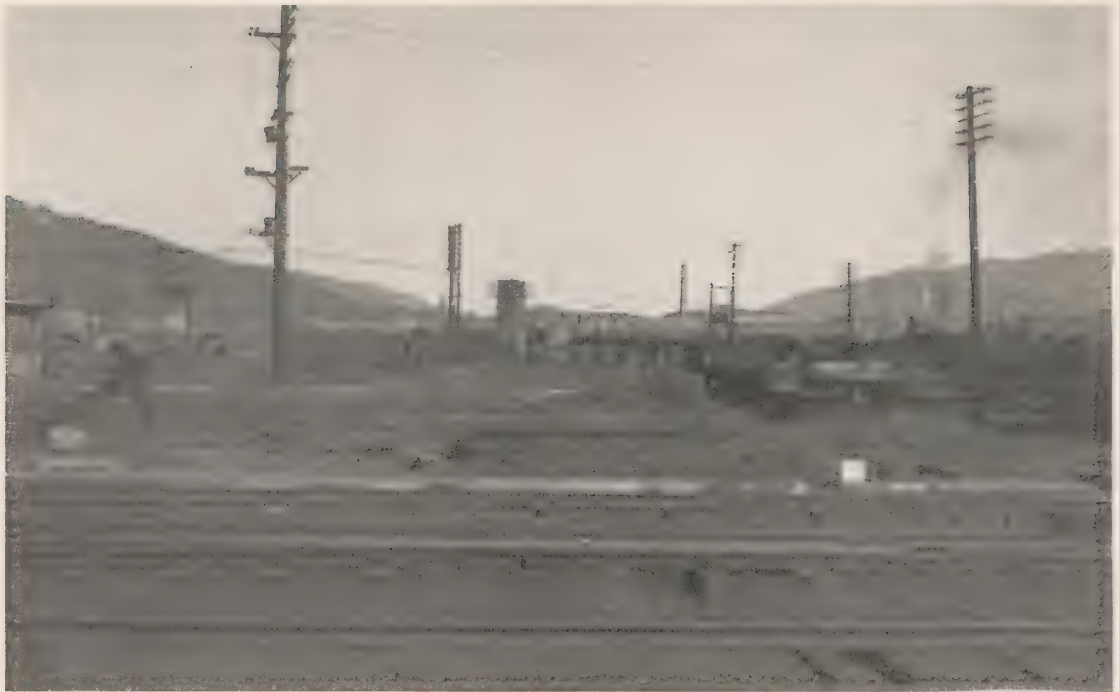
PHOTO 40-XIII. Warehouses damaged by blast, 9,500 feet from GZ.

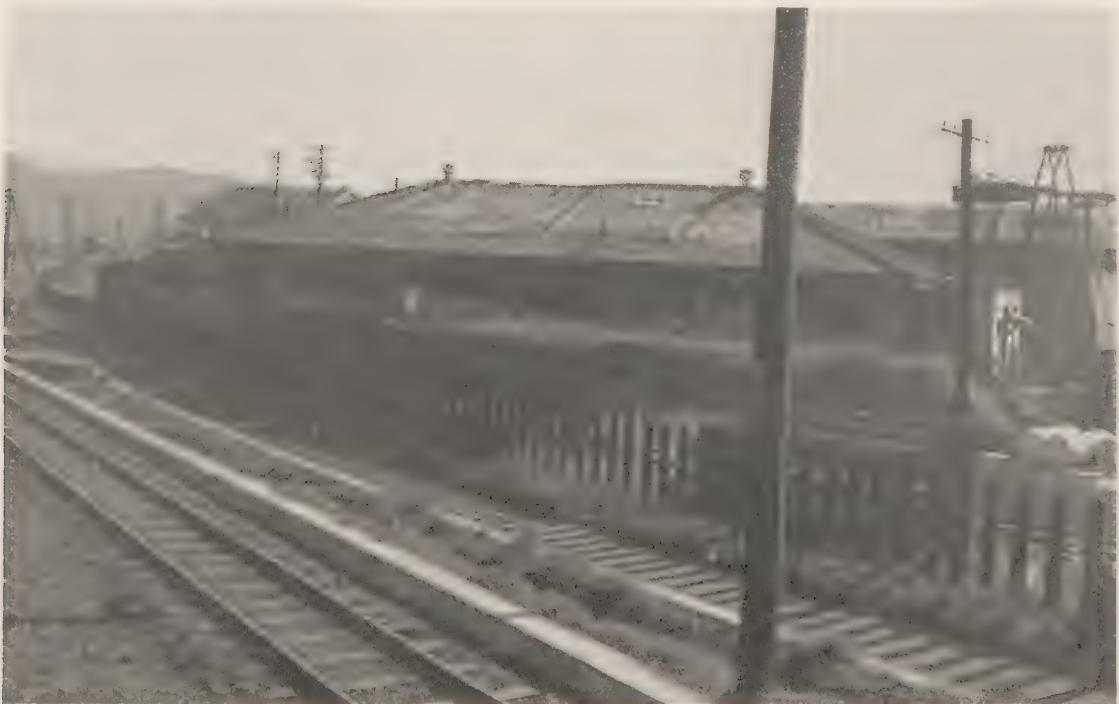
PHOTO 41-XIII. Office and warehouse damaged by blast, 9,100 feet from GZ.

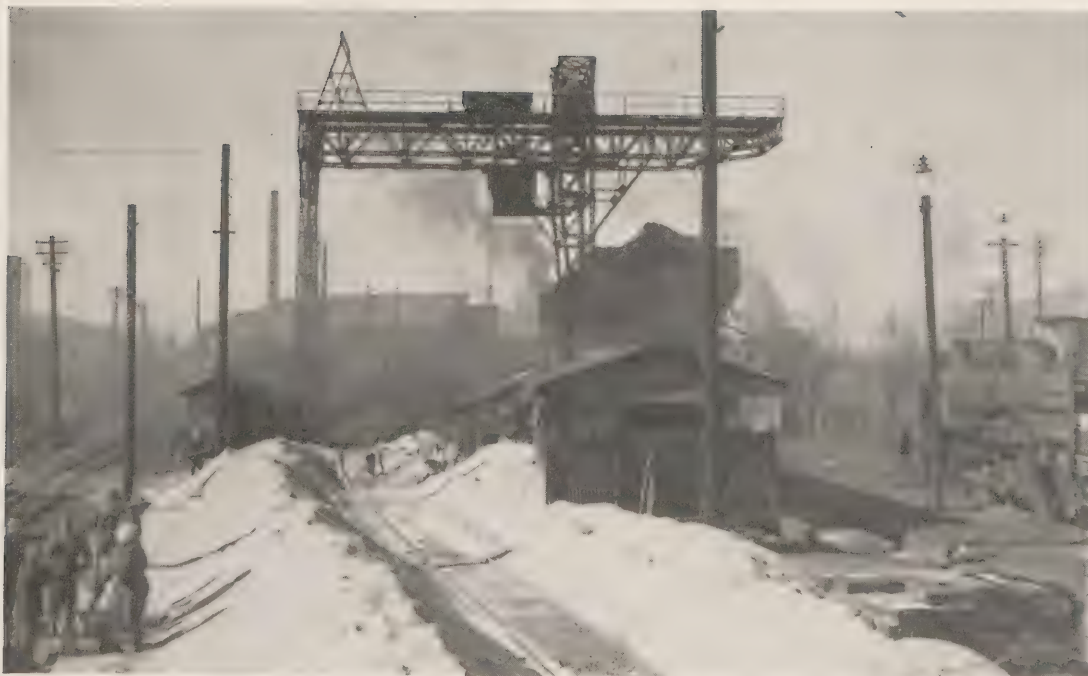
PHOTO 46 XIII. Undamaged coal bunkers and crane on south side of Roundhouse 1, 8,900 feet from GZ.

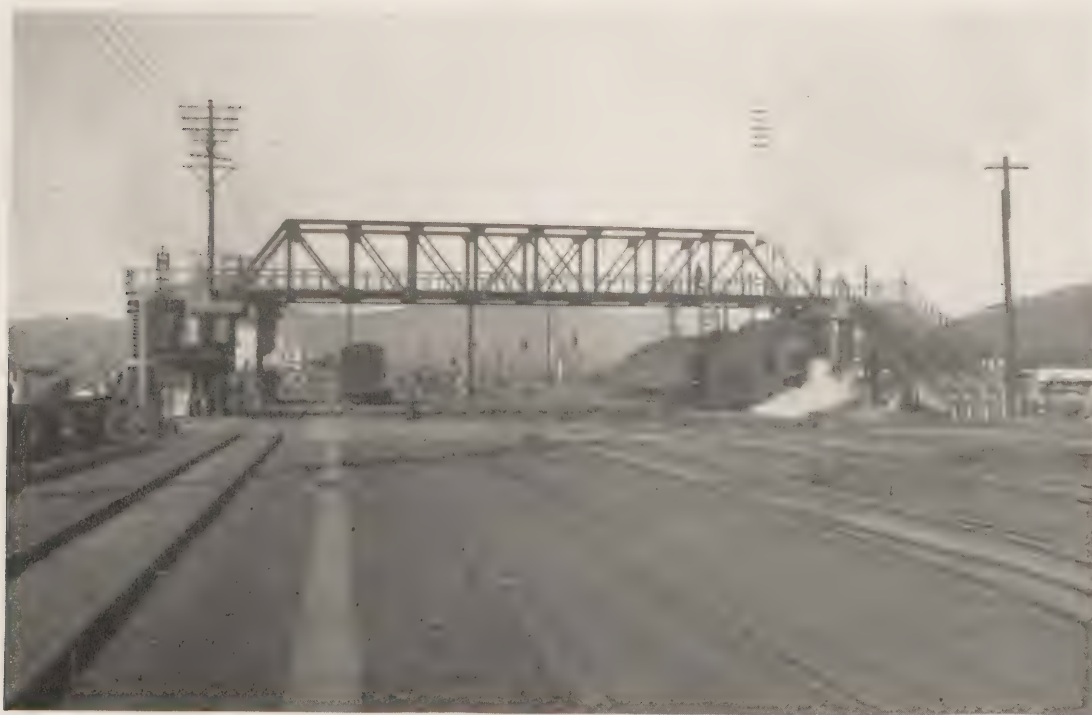
PHOTO 47-XIII. Undamaged pedestrian over-crossing south of passenger station, 6,900 feet from GZ.
